# THE RIFLES PUBLIC HOUSE, SWAN AND PIKE ROAD, ENFIELD LOCK, LONDON

## ARCHAEOLOGICAL EVALUATION

Report Number: R1036

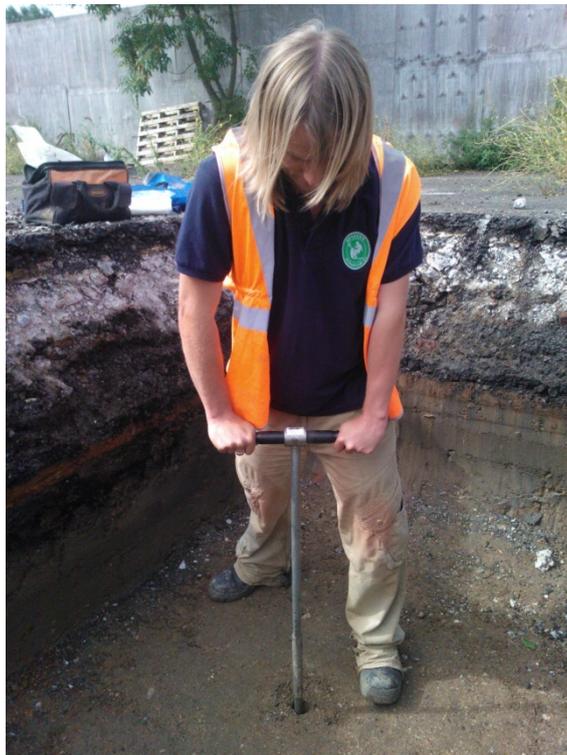
DP11; Trench 3, Borehole 3, Auger Assessment

Five augured boreholes were located in the bottom of each trench (DP11) to assess the quality of surviving sediments below that which could be safely reached by mechanical excavation. They were spatially positioned to provide good coverage across the whole site.

A Van Walt 0.5m narrow-gouge hand corer was initially used to record the layers (Appendix 1 Tables 2, 4, 6, 8, and 10, Figure 6) until the gravel river bed (1022) was encountered. After this initial assessment, one layer (1020) was re-augured using a 0.5m wide-gouge hand corer to remove, clean, package, mark-up and level a sample of peat

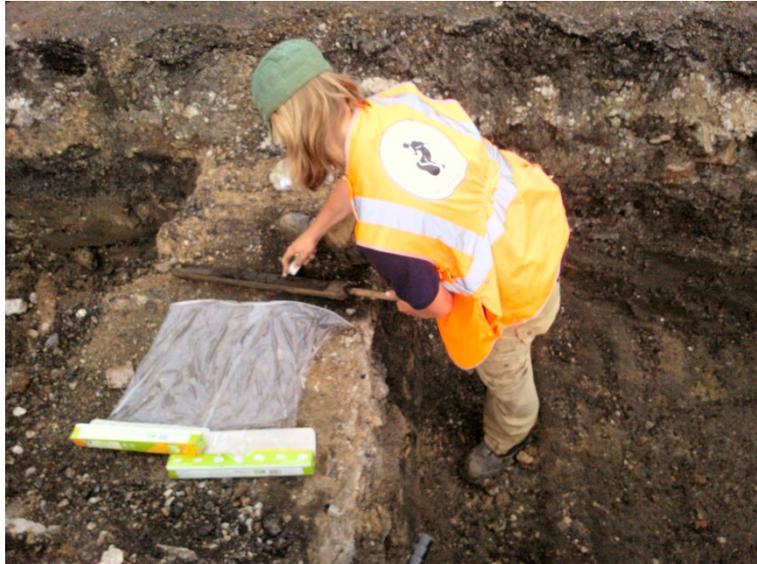
DP12; Trench 1, Borehole 1, Preparing Sample 1

soil (Sample 1) and sent to Dr Steve Boreham of Cambridge University (see Appendix 2) for further analysis.

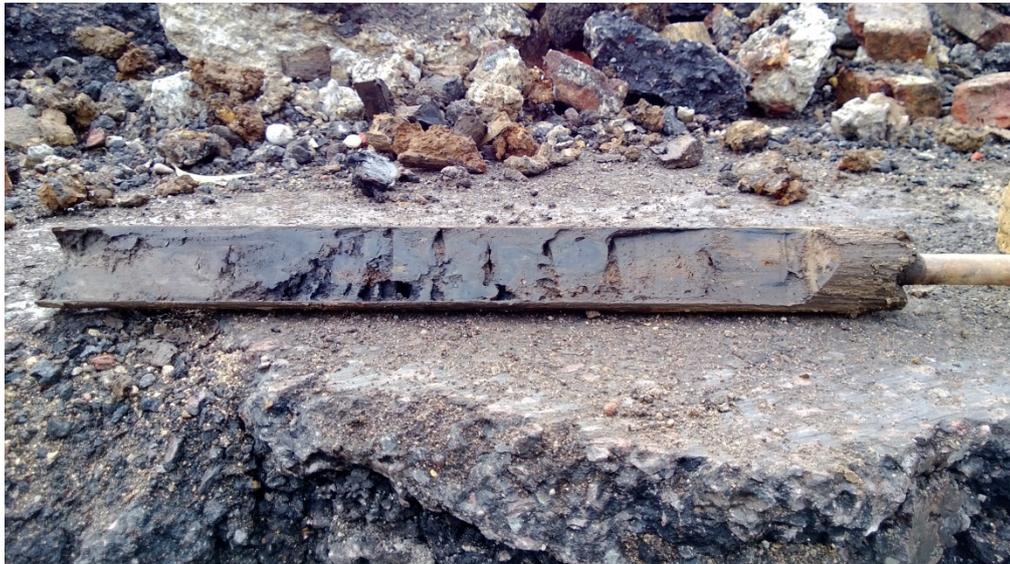
DP13; Trench 1, Borehole 1, Wide-Gouge Augered Sample 1

This report presents the results of assessment pollen analyses of two sub-samples of organic sediment from a 50cm long core taken from beneath an archaeological trench (SWN13) at Enfield, London. Pollen sub-samples were taken at 5cm and 45cm from the base of the 50cm long core (see DP13 below).

Both pollen sub-samples showed signs that the peat had undergone a large amount of post-depositional oxidation. Preservation was very poor indeed and very few pollen grains had survived the microbial attack so that the only palynomorphs seen were heavily armoured types like Asteraceae and undifferentiated monolet fern spores, often in an advanced state of decay. These amounted to little more than ten identifiable palynomorphs per slide. These

The poor preservation of pollen and spores in these sub-samples strongly suggests that the organic sediments had experienced prolonged exposure to fluctuating water tables, and that aerobic microbial degradation of organic material has reached an advanced state. It seems very likely that the entire peat band exhibits the same poor preservation potential, not just for pollen, but for other organic remains too. The apparently modest oxidation observed in the peat is most likely due the reversible nature of redox reactions. This means that in the past water tables have been lower and oxidation has proceeded apace, but with higher water tables the signs of oxidation visible to the naked eye have been reversed by the reduction of iron oxide in anaerobic conditions. Unfortunately, once the organic material has been destroyed, a return to reduced conditions cannot resurrect it. Local water table changes can wreak havoc on the preservation potential of archaeological sediments.
